SYKIA DAM

PANEL OF EXPERTS  
REPORT

SEPTEMBER 2010

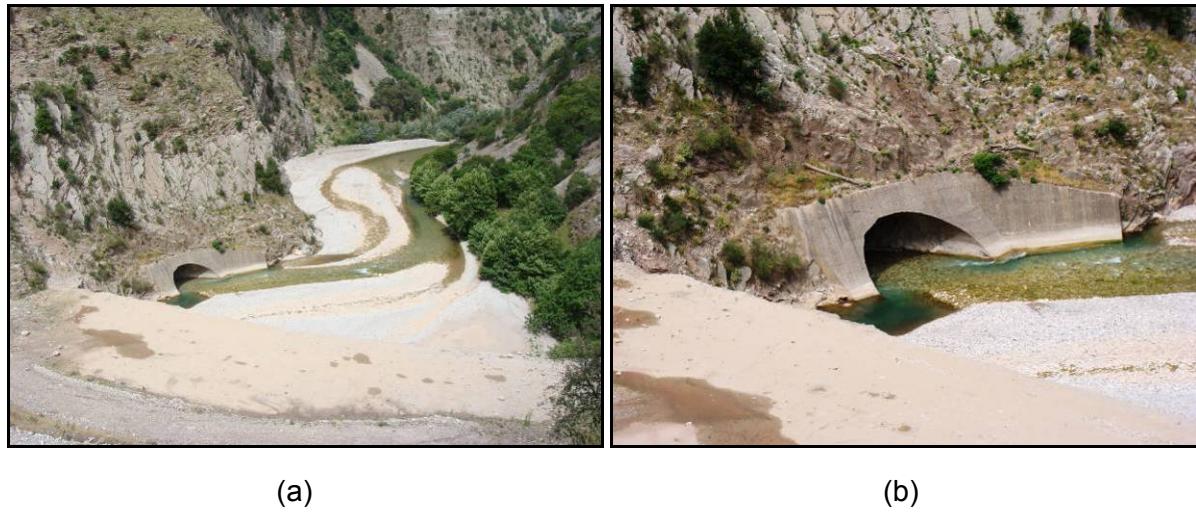
Floods have partly filled the tunnel with sediments. During the visit of the PoE to the site, the inlet portal was half filled with sediments (see Photo. 4-3), but the outlet portal was almost free of sediments (see Photo. 4-4).

**Photo. 4-3 – Koubourjiannitikos Diversion Tunnel – Inlet portal half filled with river sediments**

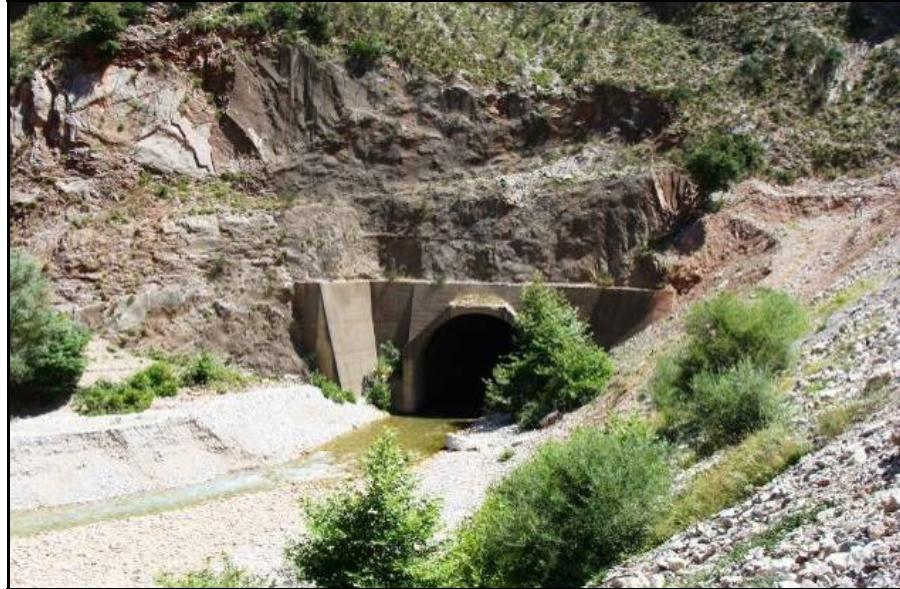
**Photo. 4-4 - Koubourjiannitikos Diversion Tunnel – Outlet portal**

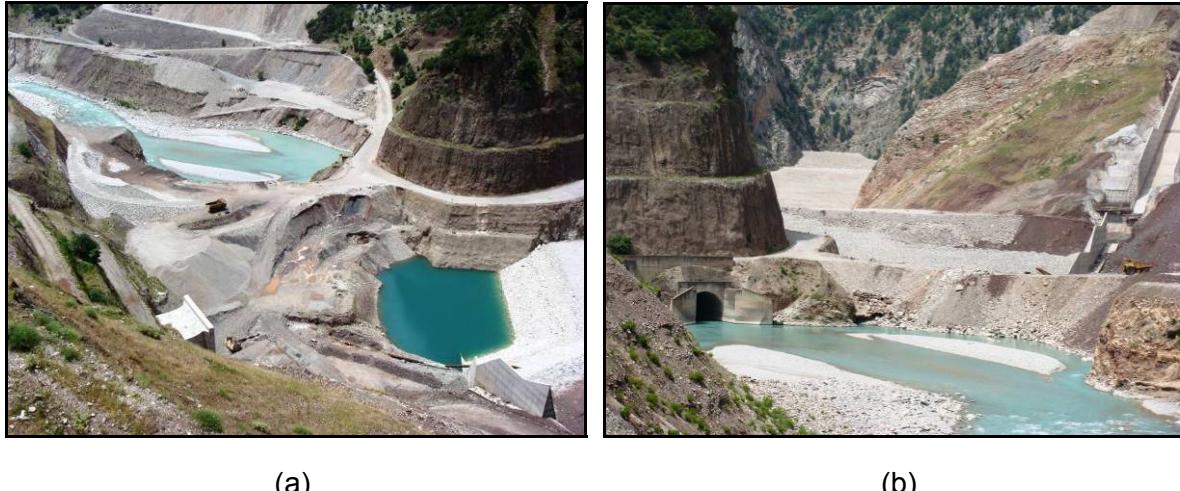
**Photo. 4-6 – Downstream Cofferdam – (a) U/S view – (b) D/S view**

Part of the cofferdam was eroded away during the 2009 flood (see Photo. 6-2) and was repaired at a later stage, as shown in Photo. 4-6 b.

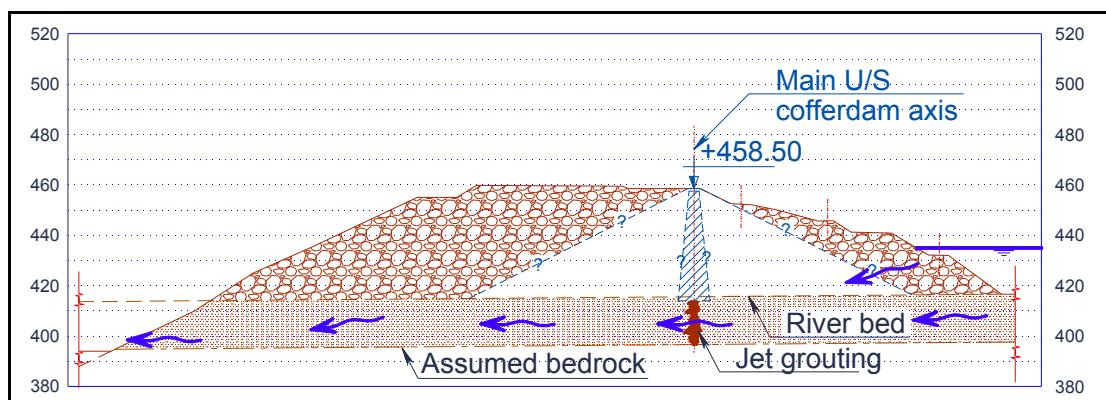
Nevertheless, during excavations in the river bed, significant filtrations were observed into the excavation areas, which indicated percolation of water through the alluvial under the MUCs (as shown diagrammatically in Fig. 4-8) and the lack of functionality of the water-tightening methods used (i.e. jet grouting and tube a manchette).

Fig. 4-10 - MUC – Filtration through river alluvia

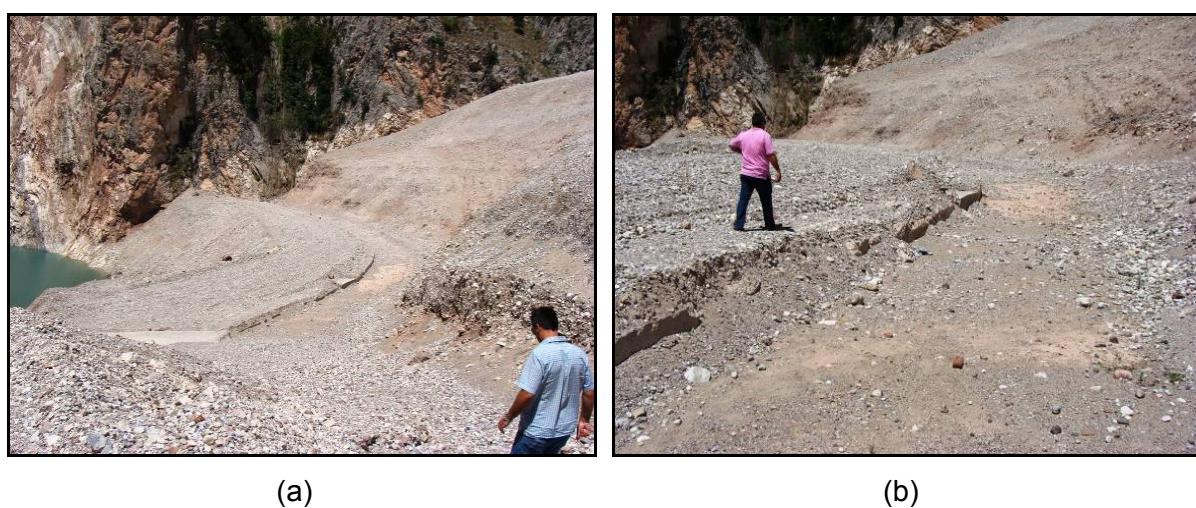
The diaphragm wall has a maximum height of 42 m and it penetrates ~2 m into the foundation rock. The total surface area of the wall is  $5.670 \text{ m}^2$ . The berm excavated on the D/S face of the dam shell is shown in the Photo. 4-9.

**Photo. 4-9 – Berm on the D/S face of the dam shell and top of diaphragm Wall**

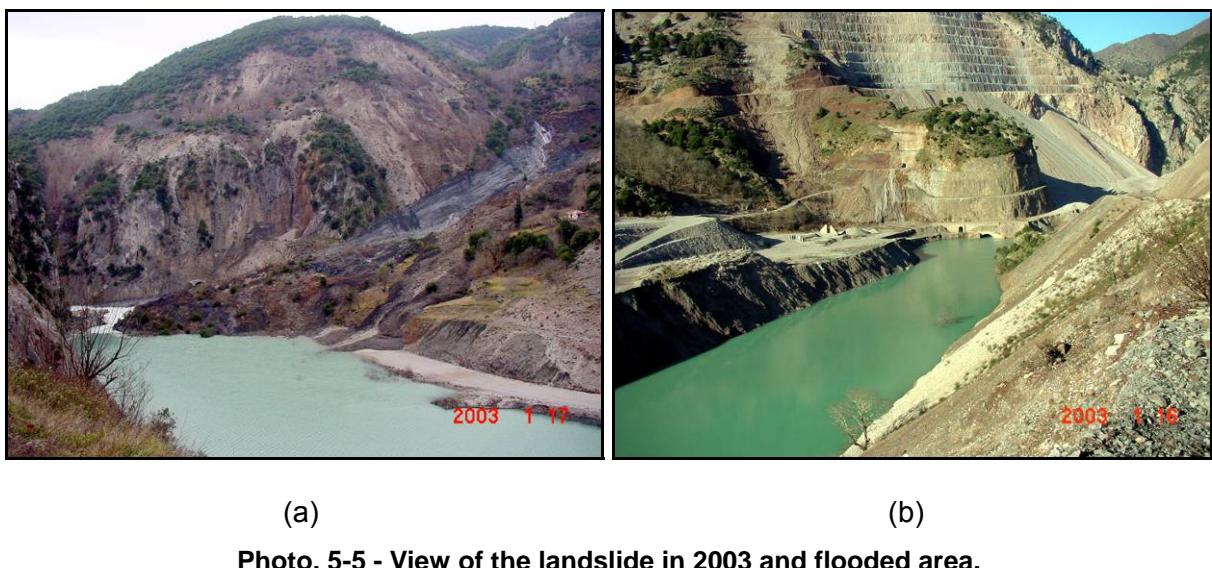
On the 15<sup>th</sup> of January 2003 a landslide occurred on the right bank, downslope of "Fryxolia Spring". The landslide was a mudflow flow in the flysch of Gavrovo zone including debris, which blocked Acheloos River (see Photo. 5-5 a) and flooded the upstream areas, forming a 25 m deep lake (see Photo. 5-5 b).

**Photo. 5-5 - View of the landslide in 2003 and flooded area.**

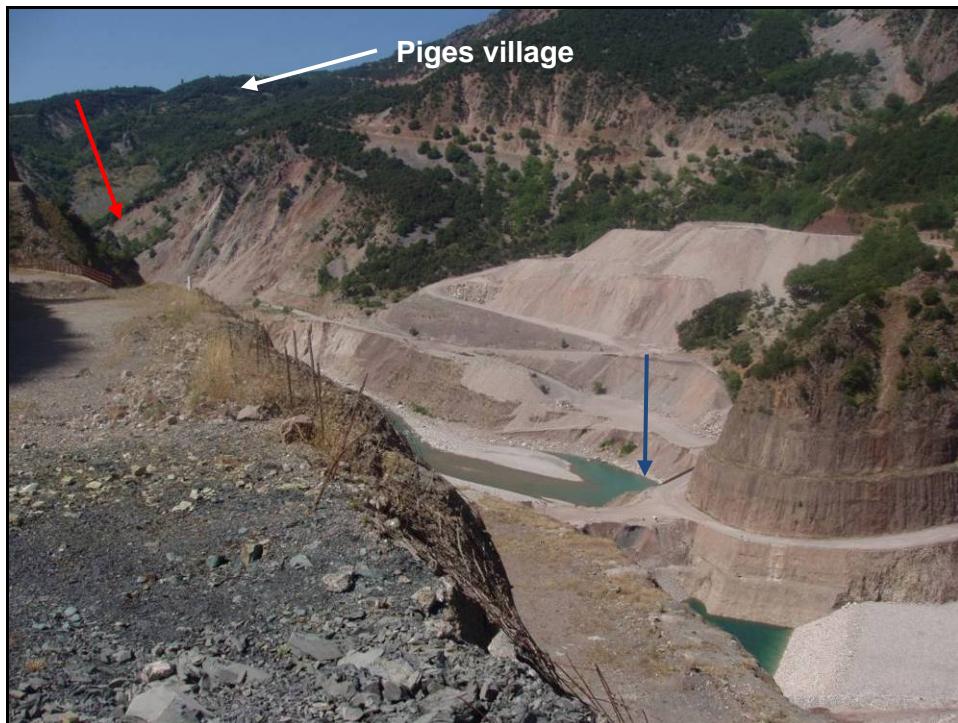
**Photo. 5-6 - View of the downstream area. The exit of Acheloos diversion tunnel is shown (blue arrow), as well as Piges village and the 2003 landslide at the background (red arrow).**

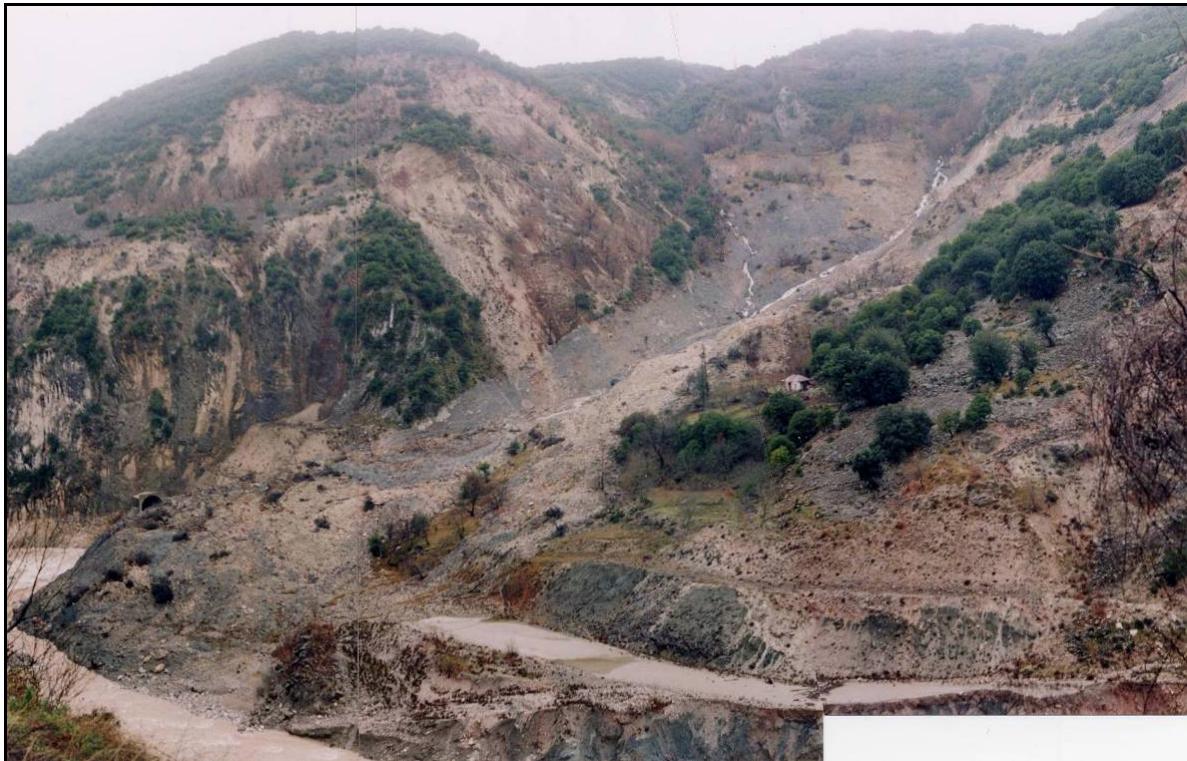
**Photo. 5-7 - View of the landslide in 2006.**

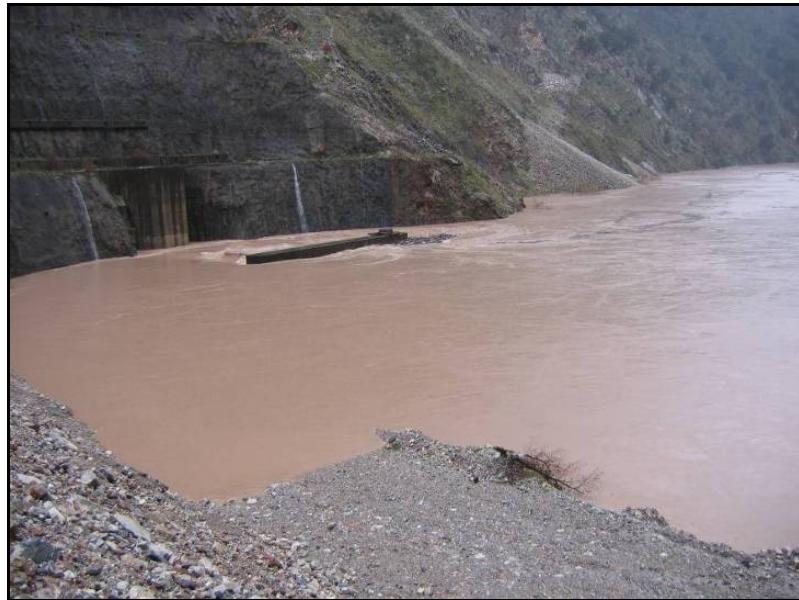
**Photo. 6-1 - 2009 Flood: Intake of Acheloos Diversion Tunnel**

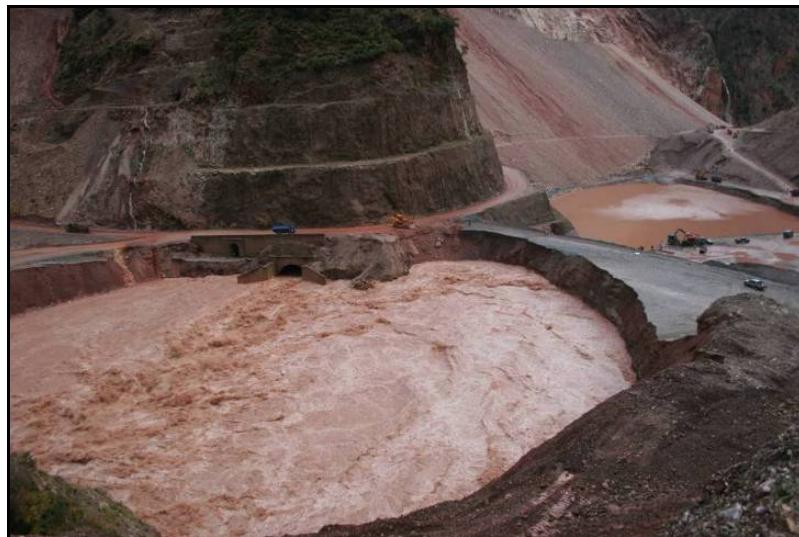
**Photo. 6-2 – 2009 Flood: Outlet of Acheloos Diversion Tunnel – Erosion of cofferdam**

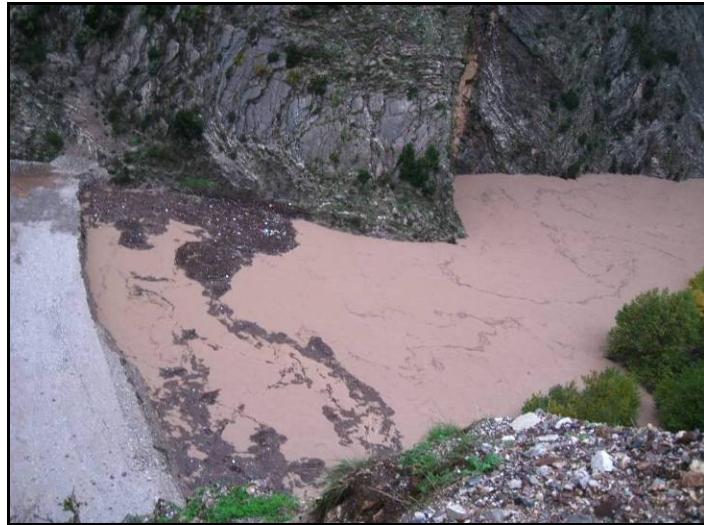
**Photo. 6-3 - 2009 Flood: Intake of Koubourjannitikos Diversion Tunnel**

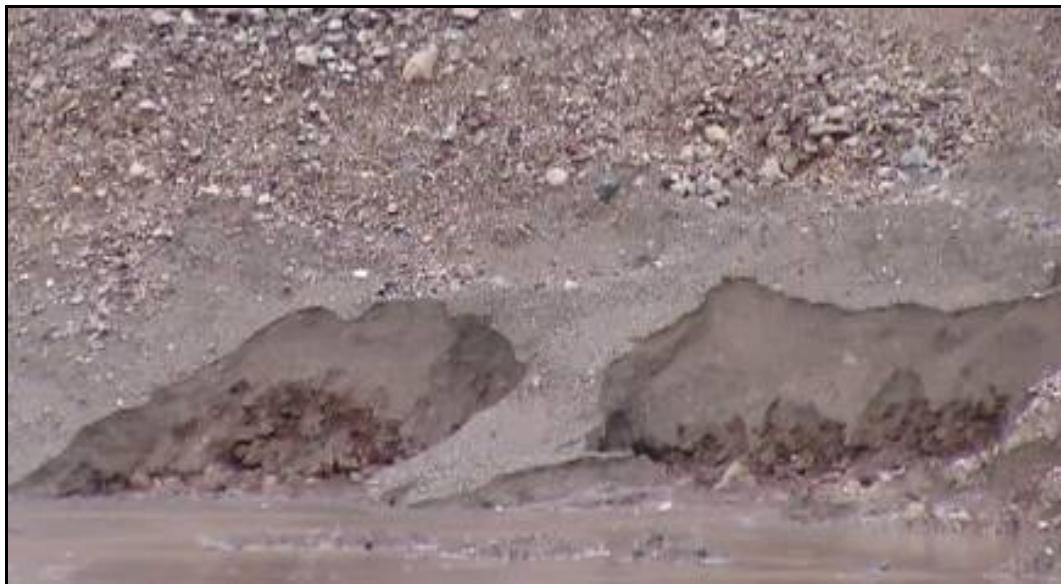
**Photo. 6-4 - Piping and water flow above the crest of the diaphragm wall**

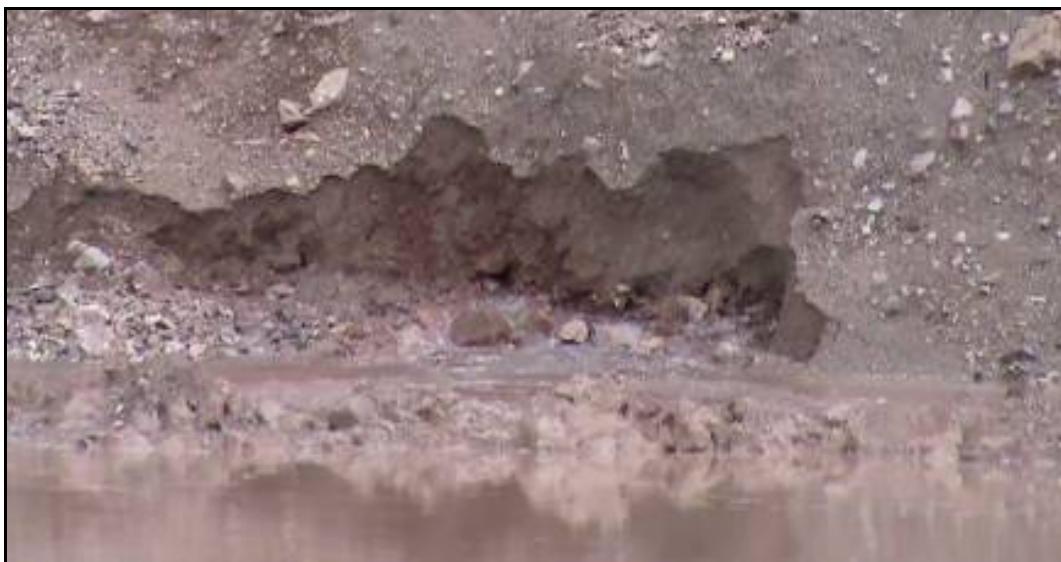
**Photo. 6-5 - Piping and water flow above the crest of the diaphragm wall**

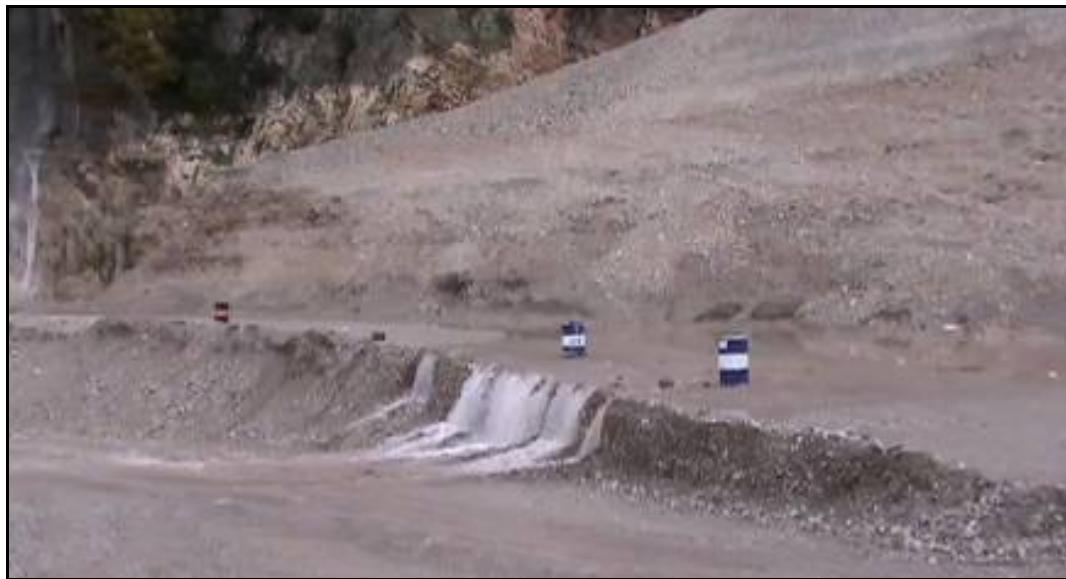
**Photo. 6-6 - 2009 Flood - Water flow over the crest of the diaphragm wall.**

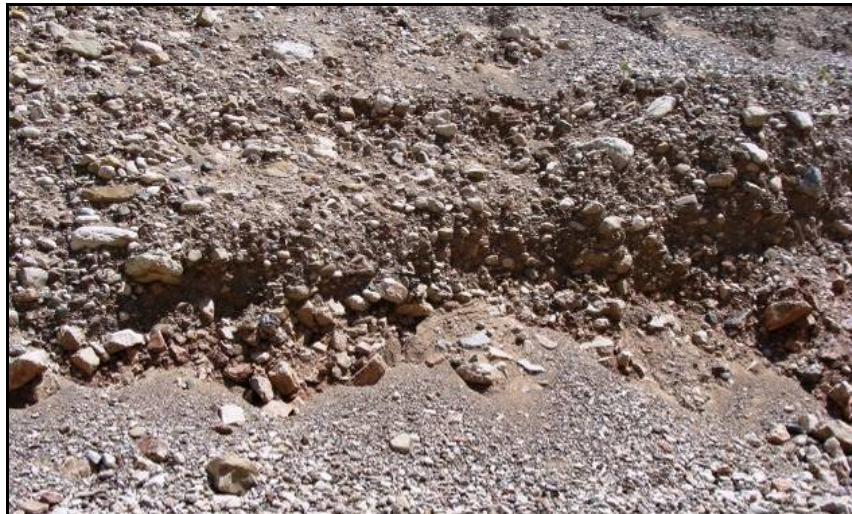
**Photo. 6-7 – Formation of open gravels after washing of fines from dam shell**
