SYKIA DAM

PANEL OF EXPERTS  
REPORT

SEPTEMBER 2010

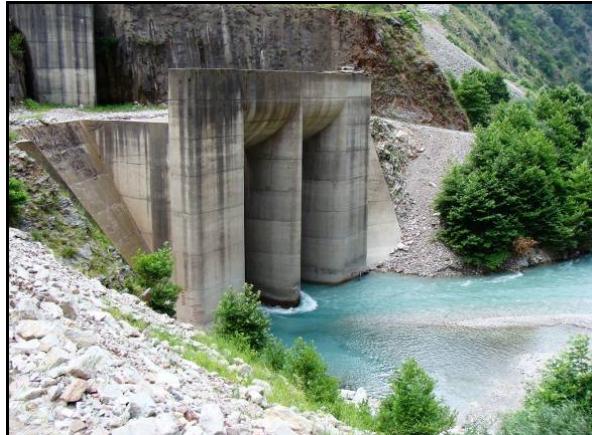
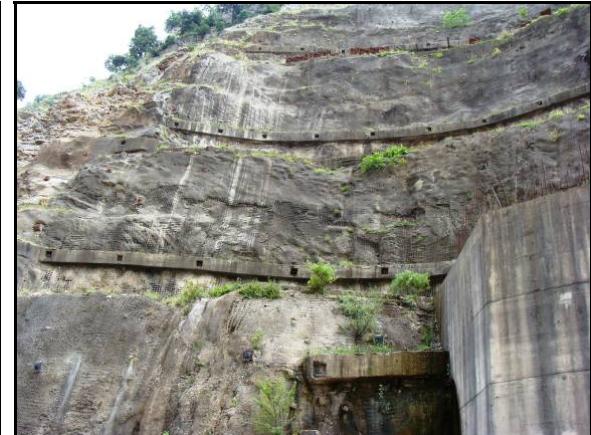
The DT-1 inlet portal is connected with the inlet of the Bottom Outlet (see Photo. 4-1 a). The open excavations at the inlet portal have been extensive and the slopes are supported by pre-stressed anchors, as shown in Photo. 4-1 b. The pre-stressed anchors have not been maintained since their installation in the mid 80's.

**Photo. 4-1 – Acheloos Diversion Tunnel Inlet (a) and portal excavation support measures (b)**

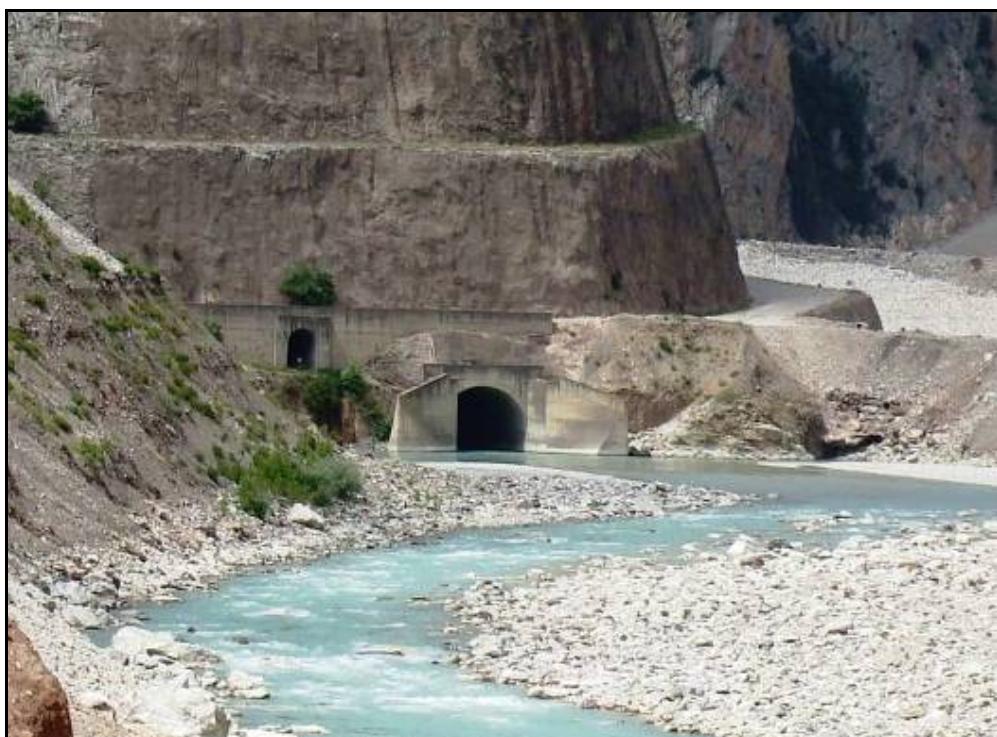
**Photo. 4-2 - Acheloos Diversion Tunnel – Outlet Portal**

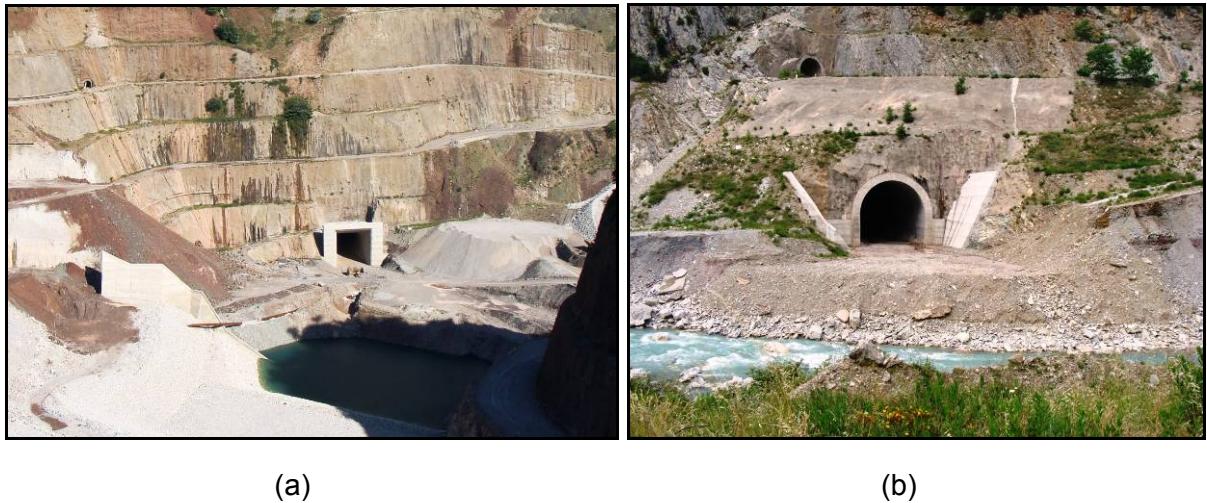
The inlet portal (see Photo. 4-5 a) is located in-between the toe of the dam shell and the main D/S cofferdam.

The elevation of the invert at the inlet portal is +410.00 and at the outlet portal +400.00. The outlet portal is shown in Photo. 4-5 (b).

**Photo. 4-5 – Additional Diversion Tunnel – (a) Inlet portal, (b) Outlet portal**

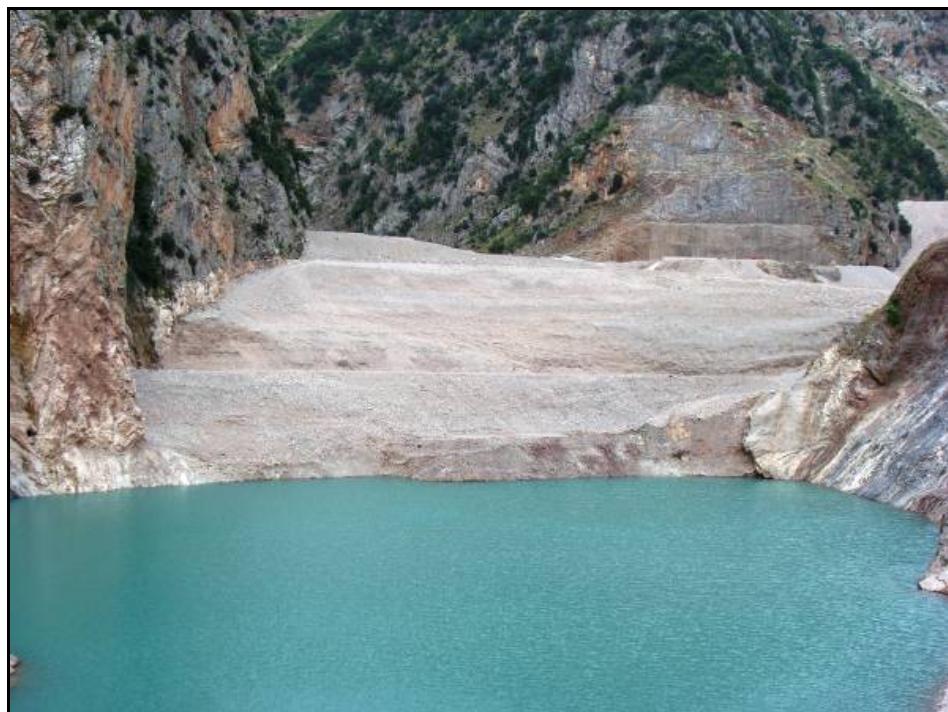
The design of the dam foresees that both MUCs shall be incorporated in the upstream shell of the dam. So, the dam contractor has placed considerable volume of shell materials mainly on the downstream face of the Acheloos MUC as shown in Fig. 4-7 (see also Photo. 4-7).

**Photo. 4-7 - Upstream Dam Shell – View from D/S**

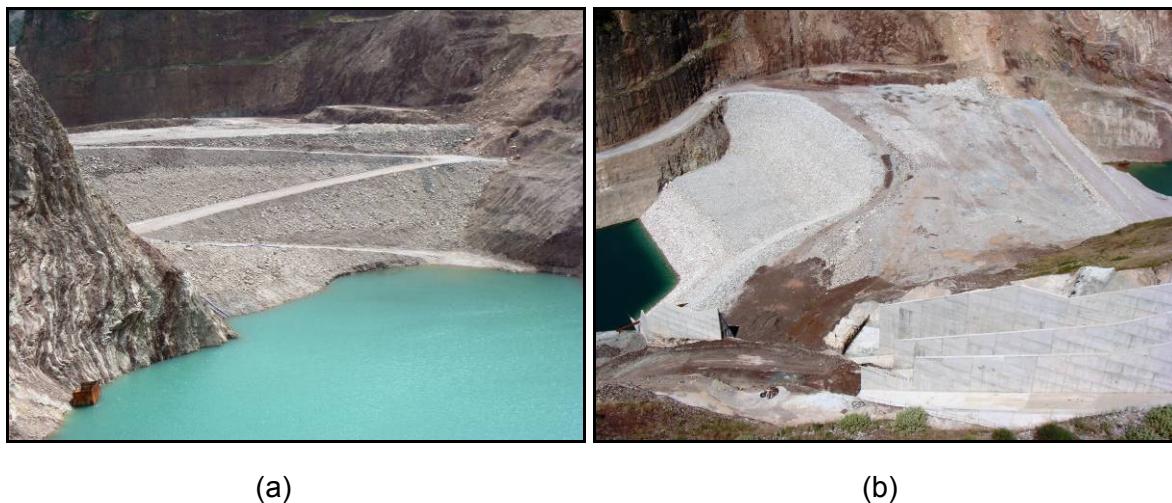
The dam contractor constructed part of the downstream dam shell, in-between the core trench excavation and the main D/S cofferdam. Views of the D/S shell are shown in Photo. 4-8 (a) and (b).

Photo. 4-8 – Downstream dam shell – (a): U/S view – (b): D/S view

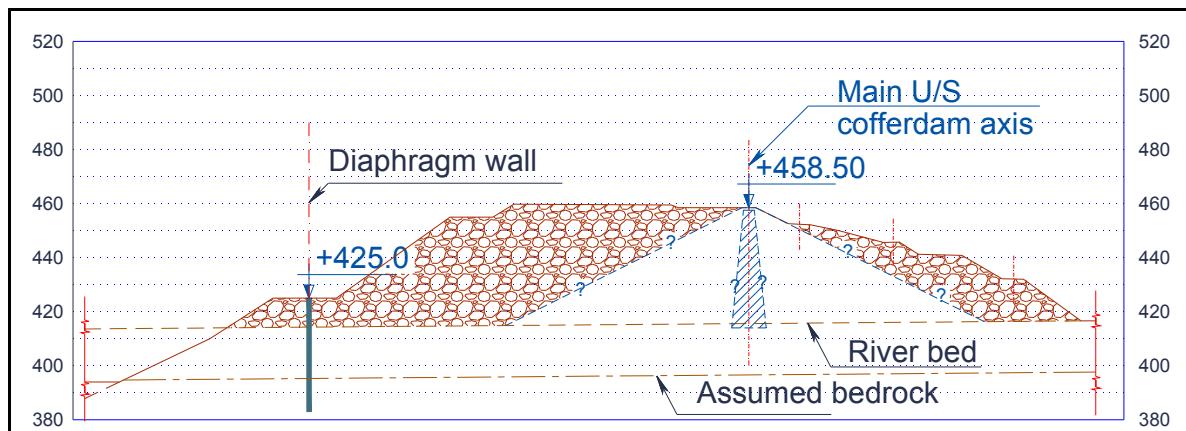
Based on technical and economic evaluation of the various alternatives, it was finally decided to construct a positive concrete diaphragm wall. Originally the diaphragm wall was located upstream of the cofferdam axis, but due to extremely high bentonite slurry takes, the trench walls could not be stabilized. It was finally decided to construct the wall downstream of the cofferdam axis, from a berm at elevation +425, as shown Fig. 4-10. At the time this decision was taken, it seemed a proper decision, since construction of the dam core was eminent and it would be raised above elevation +425 in a relatively short period of time.

**Fig. 4-11 – Section of U/S Dam Shell and Location of Diaphragm Wall**

The diaphragm wall has a maximum height of 42 m and it penetrates ~2 m into the foundation rock. The total surface area of the wall is  $5.670 \text{ m}^2$ . The berm excavated on the D/S face of the dam shell is shown in the Photo. 4-9.

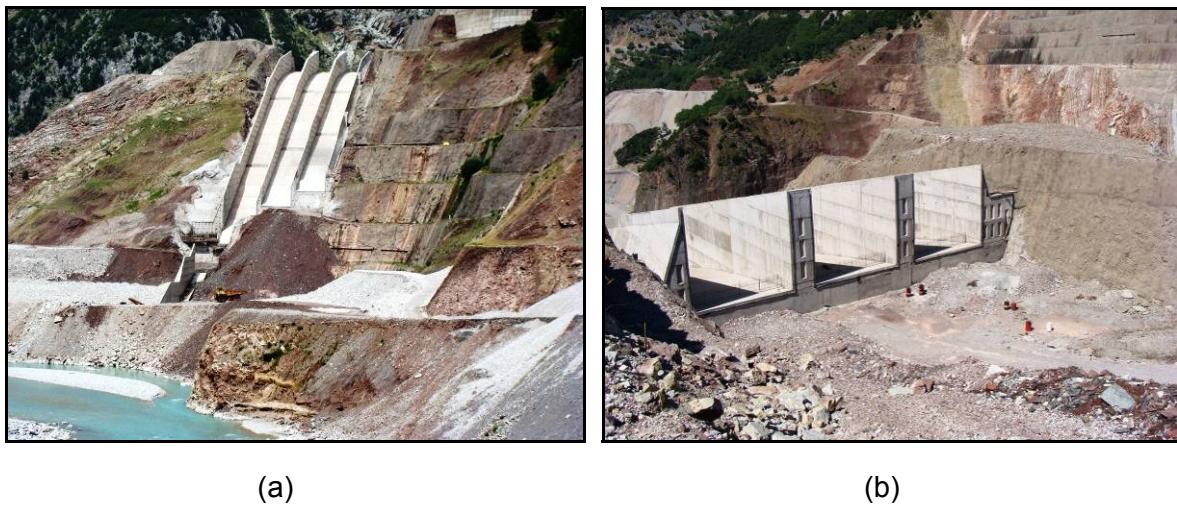
The excavations of the spillway chute and a large part of the concrete structures have been completed, as can be seen in Photo. 4-10 a. The U/S end of the chutes is shown in Photo. 4-10 b.

There have been no works in the flip bucket area and the plunge pool.

**Photo. 4-10 – Spillway – (a): Three Channel Chute, (b): Upstream View of Channels**

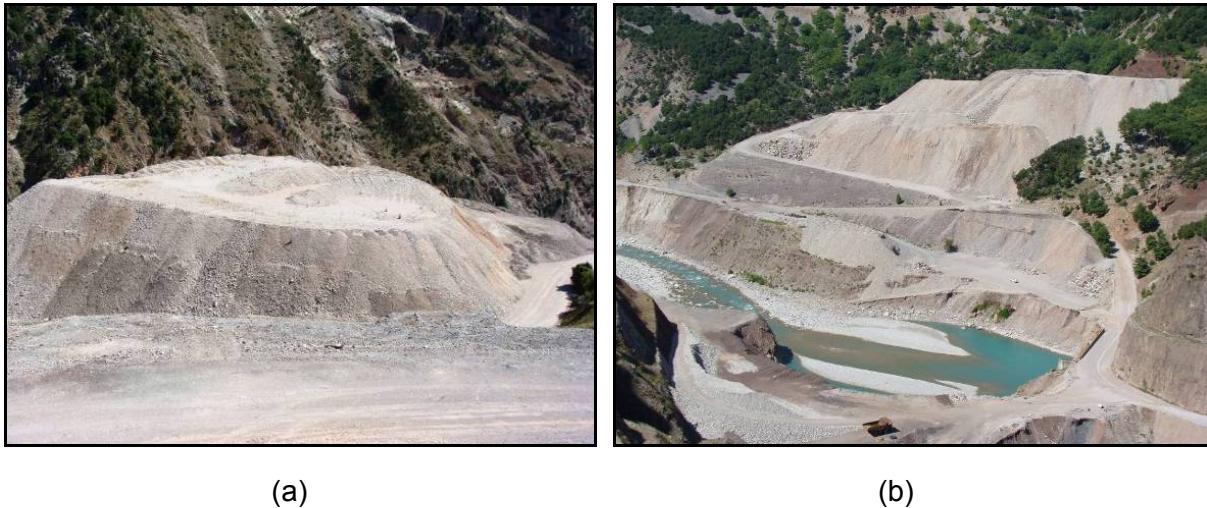
Considerable volume of materials suitable for dam shell construction have been stockpiled on the Koubourjiannitikos MUC (see Photo. 4-11 a) and on the right bank downstream of the dam site (see Photo. 4-11 b). Unconfirmed information raises the volume of the stockpiled materials to  $\sim 500,000 \text{ m}^3$ .

**Photo. 4-11 – Stockpiled materials – (a) on the Koubourjannitikos MUC, (b) Downstream of the dam site, on the right bank**

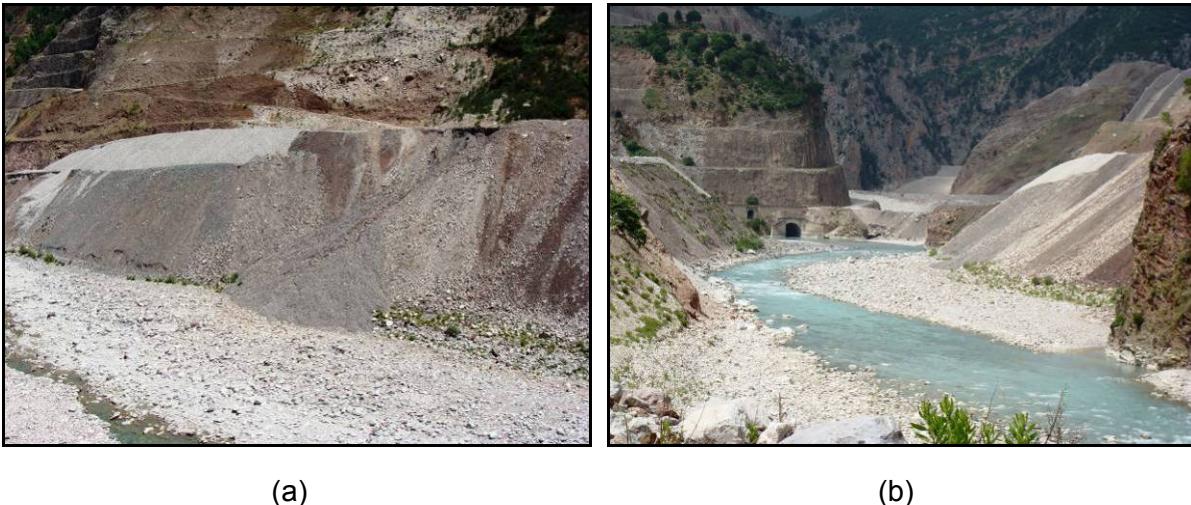
Materials unsuitable to be incorporated into the dam have been dumped on both banks downstream of the dam site. The materials dumped on the left bank are shown in Photo. 4-12.

**Photo. 4-12 - Dumped Materials – (a): D/S on the right bank, (b) D/S on both banks**

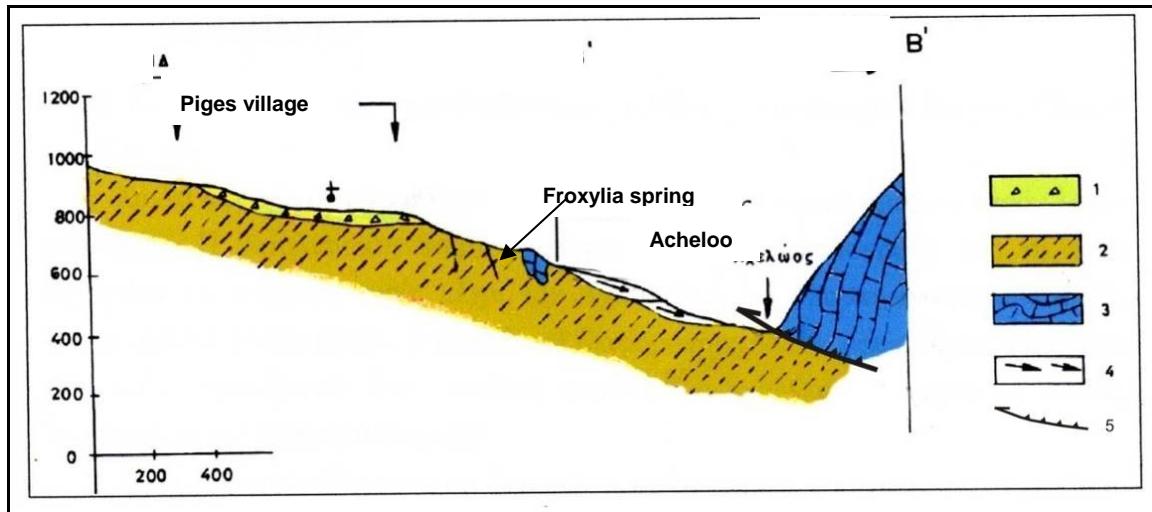
**Fig. 5-5 - Geological section of the landslide**

On 19-1-2003 surface ruptures were identified at the north of the previous landslide in a geologically sensitive zone, where instability phenomena are taking place for the last 200 years, as very slow movements of detached limestone masses and scree materials over the flysch. The above mass movements were re-activated by heavy rainfall in the period of December 2002 and January 2003.

A geological section across the landslide is shown in Fig. 5-5 and a picture of the whole area is shown in Photo. 5-6.

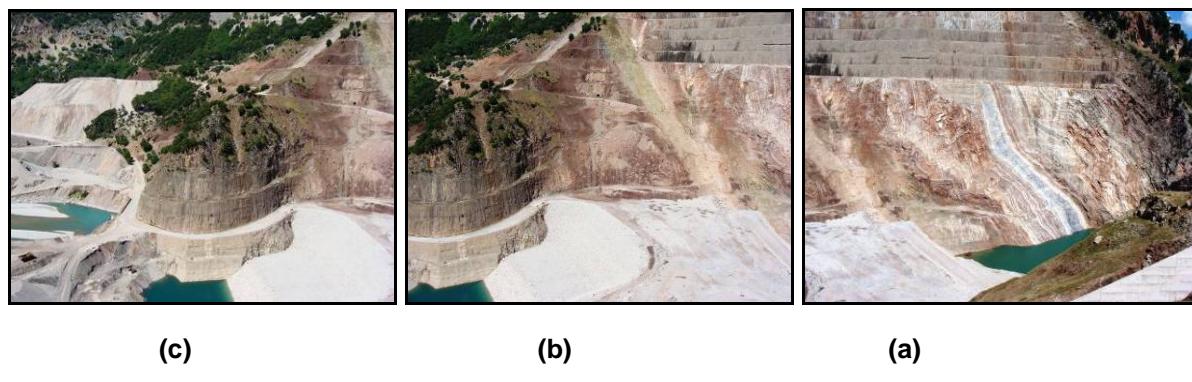
**Photo. 5-8 - Formations along the Acheloos Diversion Tunnel**

Diversion Tunnel No. 1 has been excavated over a length of ~650 m from the inlet portal, in the Upper Cretaceous Limestone (see Photo. 5-8 a). The rockmass exposed in the tunnel has been considered as competent, while the bedding is dipping favorably and nearly parallel

The next 250 m of the tunnel have been excavated in the Upper parts of the Radiolarite Series, which in the Geological Map is referred as "First flysch". The Radiolarite Series consist of reddish to greenish sandstones as well as successions of thin red marls, cherts, marly limestones, shales and mudstones (see Photo. 5-8 b). This rockmass has unvaried geometry, similar to the overlying Cretaceous Limestones. In the tunnel, these formations have been exposed as fresh rockmass, without signs of weathering, as it is experienced on the surface. The rockmass along that length of tunnel may be considered as of low resistance to erosion by water flow.

The last 50 m of tunnel have been excavated in thinly bedded limestones of the Radiolarite Series (see Photo. 5-8 c), which are fresh and with the same geometry as above. The rockmass along that length of tunnel may be considered as of medium resistance to erosion by water flow.

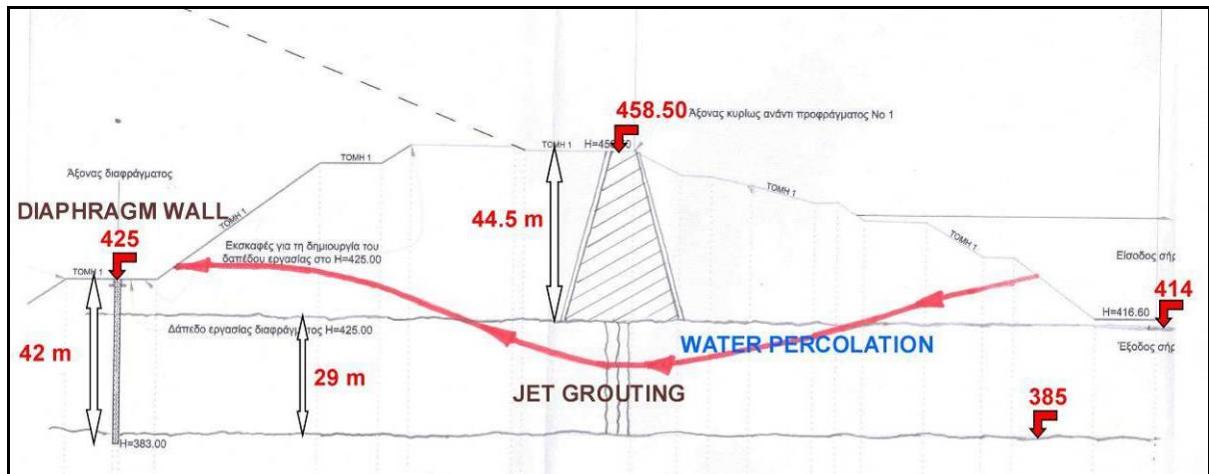
**Fig. 6-7 - Cross section of the achellos cofferdam and upstream dam shell.**

It is believed that water seeping through the alluvia deposits under the MUC, is forced by the watertight diaphragm wall to emerge over its crest, as shown in Fig. 6-7. It is obvious that the higher the water level in the lake upstream of the cofferdam, the higher the water flow emerging over the diaphragm wall.

During a flood in 2009, (after construction of the diaphragm wall), the water level upstream of the cofferdam reached elevation +434.00 m. High water flow was observed at the downstream face of the cofferdam, above the diaphragm wall. The flow was assessed (not recorded) at  $\sim 2 \text{ m}^3/\text{sec}$ .

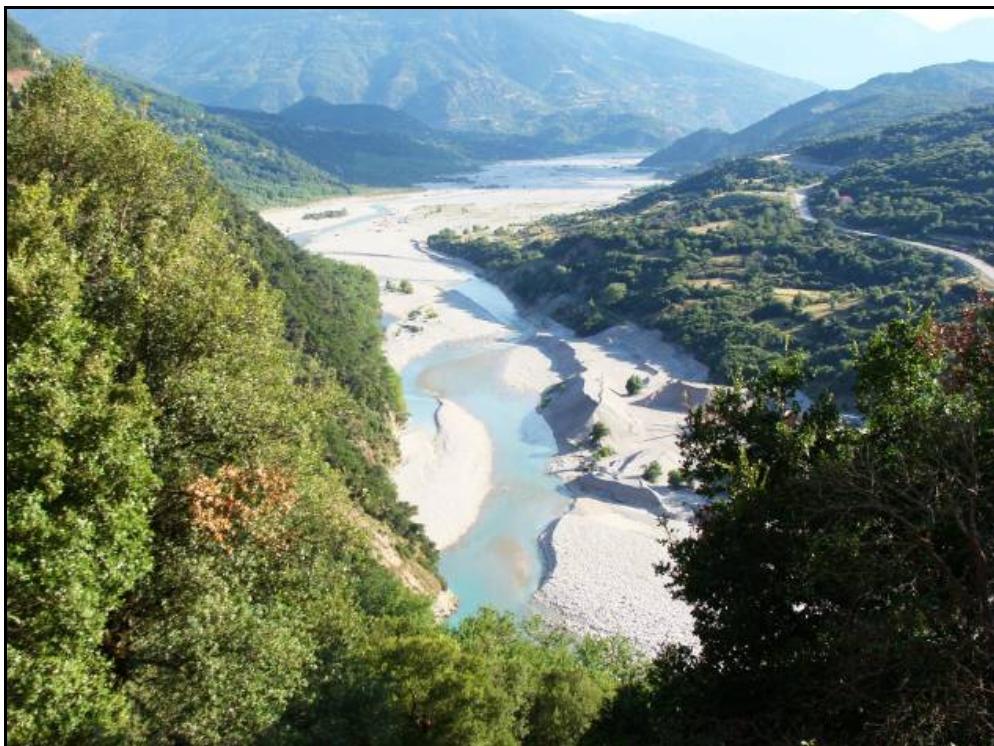
**Photo. 7-1 – Acheloos river downstream of the Korakou Bridge**

Part of the eroded materials will be trapped in the space between the U/S and D/S cofferdams. However, the flow of the river will transport sand and gravel, depending on the velocity of the flow. These materials will eventually be deposited in the wider river valley of Acheloos, downstream of the Korakou Bridge (see Photo. 7-1).

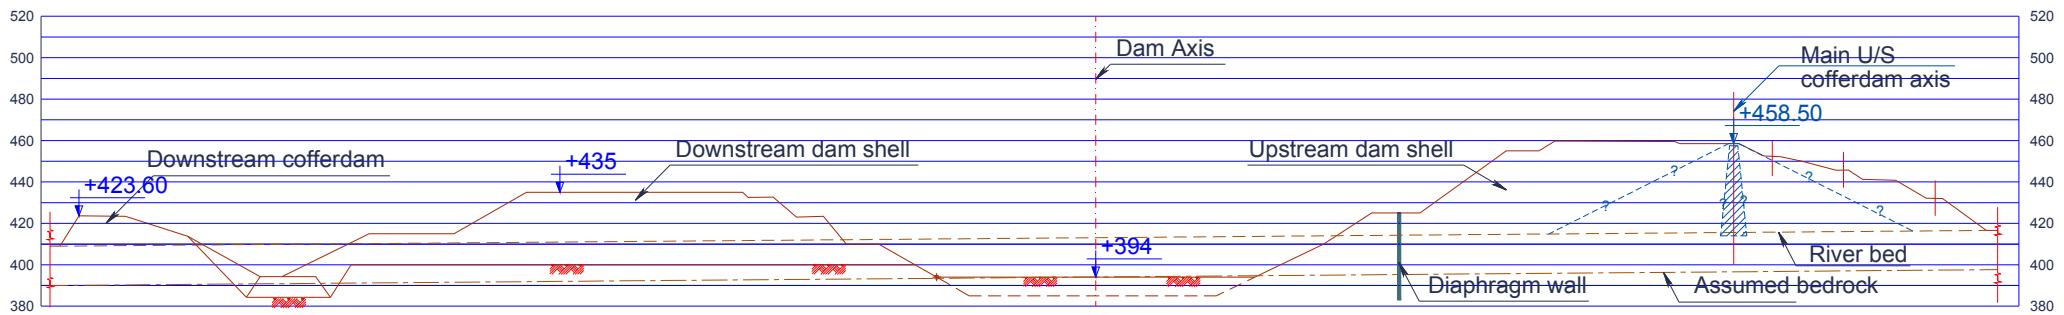
**Fig. 7-1- Typical section along the Acheloos river course**

The material of the D/S face of the D/S cofferdam will be eroded and the river will flow more or less on the present river bed.

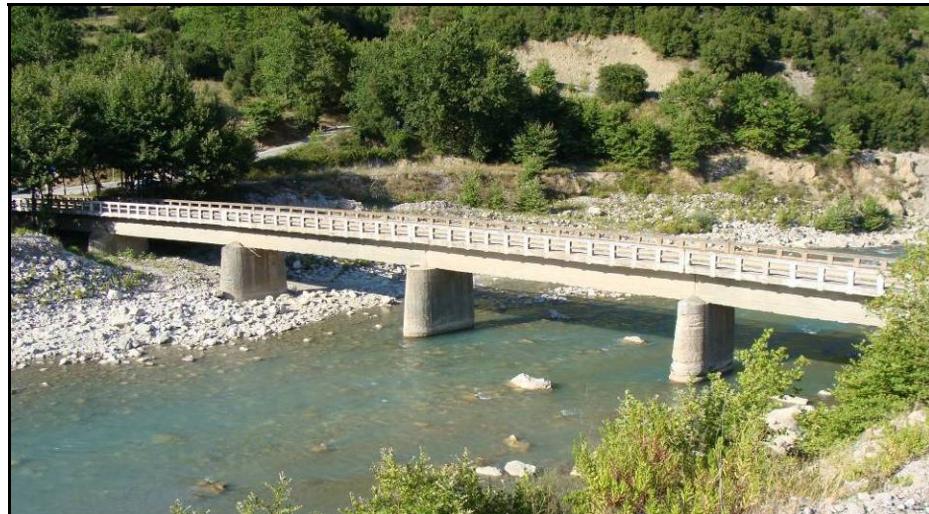
**Photo. 8-2 – Korakou Bridge**

The PoE strongly recommends that all the areas close to the river be searched for human activities and installations. Those should be mapped, recorded and their value estimated. During the visit of the PoE to the site, it was observed that close to Korakou Bridge on the left bank and practically at the same elevation as the bridge deck, a restaurant is in operation, with the proprietor living on the upper floor of the building.

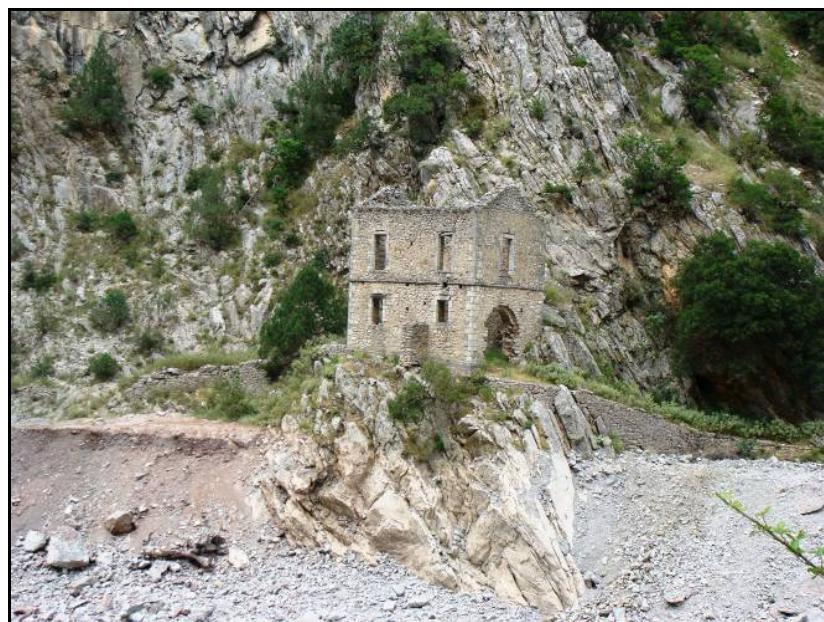
**Photo. 8-6 - Old customs building on the left bank of Acheloos River**

In addition to the bridges and the small hydro, downstream of the dam site and at a distance of ~500 m from it, is the old customs building on a protruding rock on the left bank of the river (see Photo. 8-6). This building is of historical value.
